MARINE INVESTIGATION REPORT

M00W0005

STRIKING OF A BRIDGE

THE TUGBOAT "SEA CAP XII" AND THE BARGE "T.L. SHARPE"

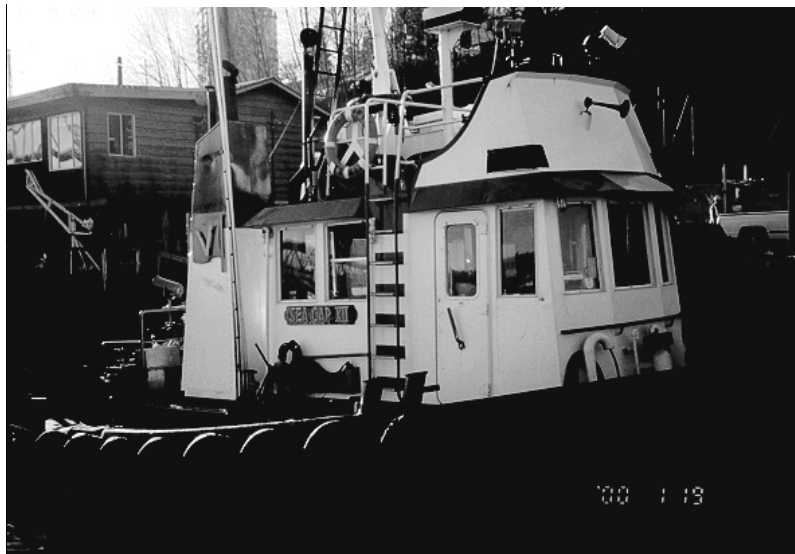
The "SEA CAP XII" is a small steel tug used mostly in the Fraser River, and occasionally for some light duties in the waters of the Strait of Georgia. It has two propellers in Kort Nozzles and four rudders connected by a bar. At the forward end of a midship deck-house is a control panel with navigation, steering and engine controls; at the after end is a galley. The deck-house, fitted with windows on all four sides, has an almost 360-degree view from the inside. The door leading to the stern of the tug is partially glassed. There are two

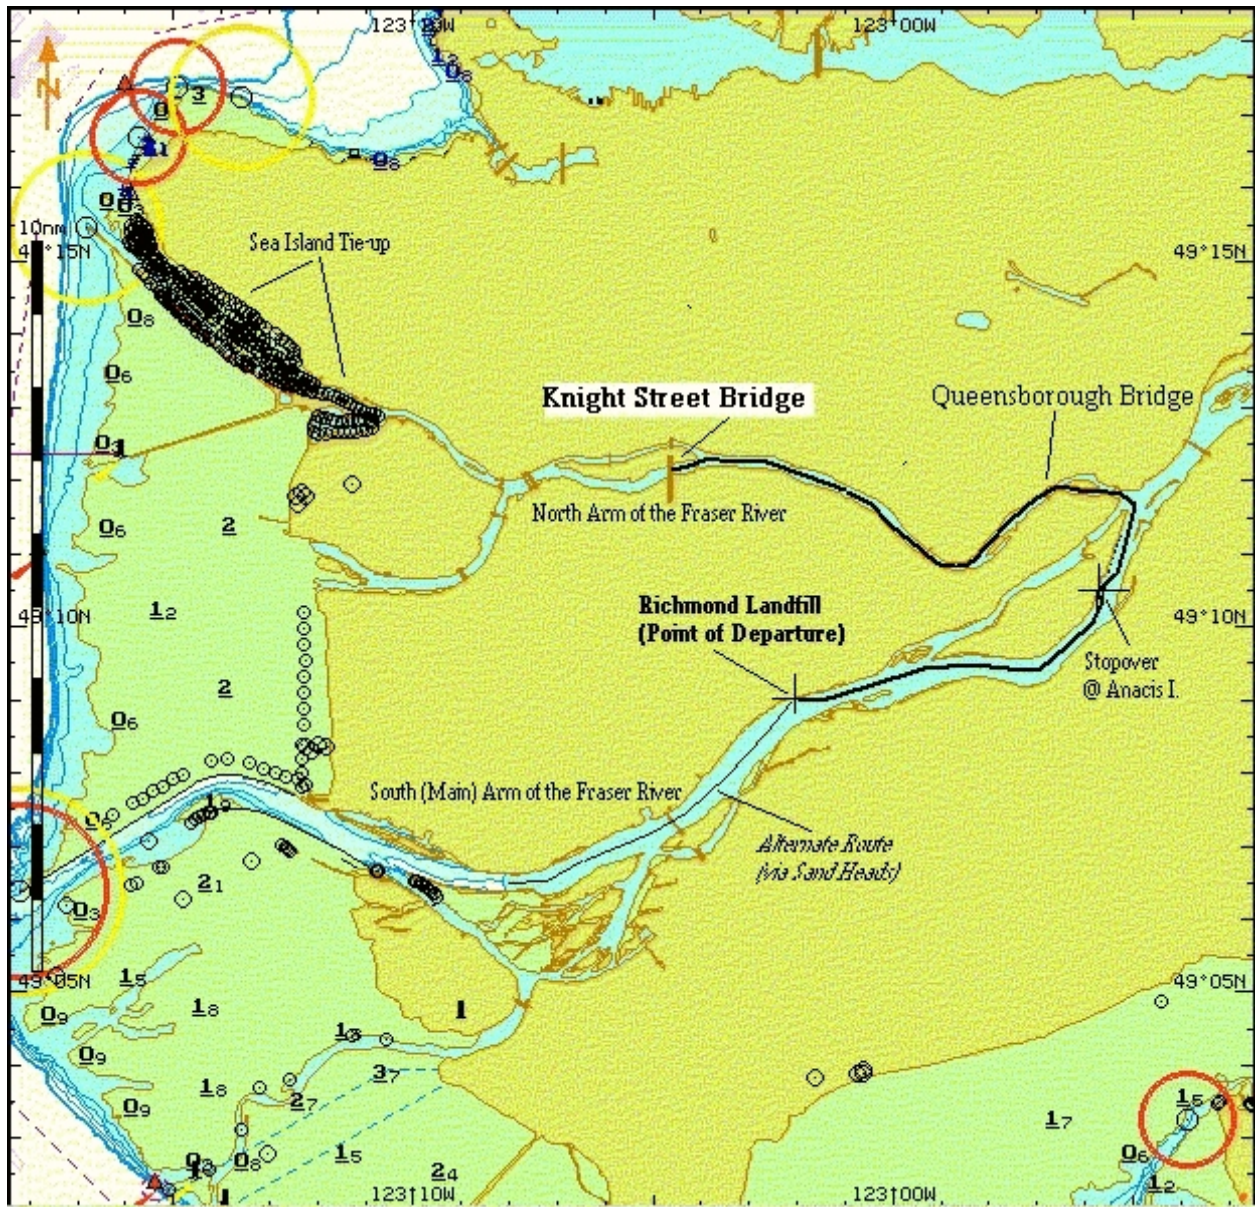
Appendix A - Sketch of the Occurrence Area

The investigation established that the sheave on top of the boom first hit the side of the eastern concrete girder slightly above the highest point of the arch, whereupon it slid under the girder and hit the steel grate and the pipes. As a result of the striking, the boom was bent and twisted and the securing arrangements between the barge and the crane were severed. The crane's machinery was water-damaged as a result of the subsequent sinking.
